Inspecting a Deck, Illustrated

by Nick Gromicko, Founder, International Association of Certified Home Inspectors (InterNACHI)
Graphics by InterNACHI's Lisaira Vega

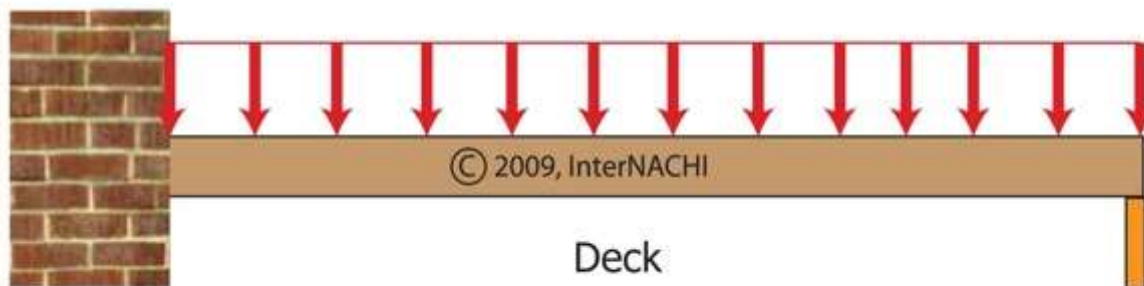
The image above depicts an evenly distributed deck load. Building codes require decks to be

designed to carry a uniformly distributed load over the entire deck. If evenly distributed, half of the load is carried by the deck-to-house connection, and the other half is carried by the posts.

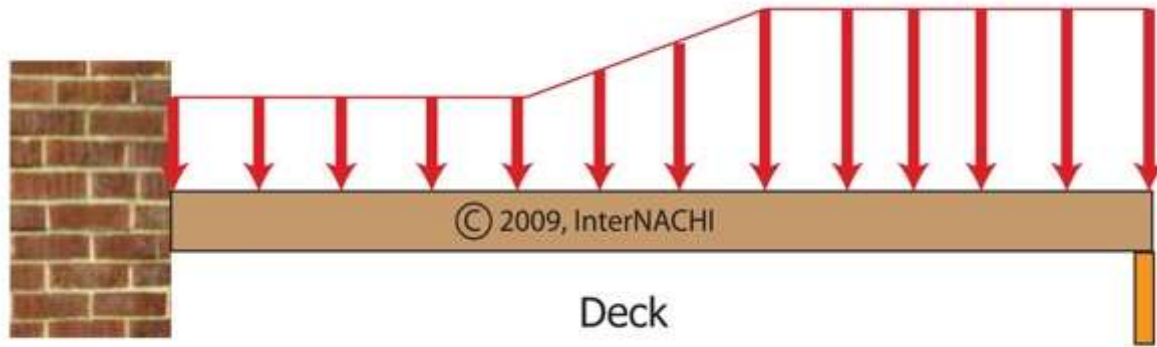
The image above depicts a typical deck load distribution. People tend to gather near the railings of a deck, and so more load is likely carried by the posts.

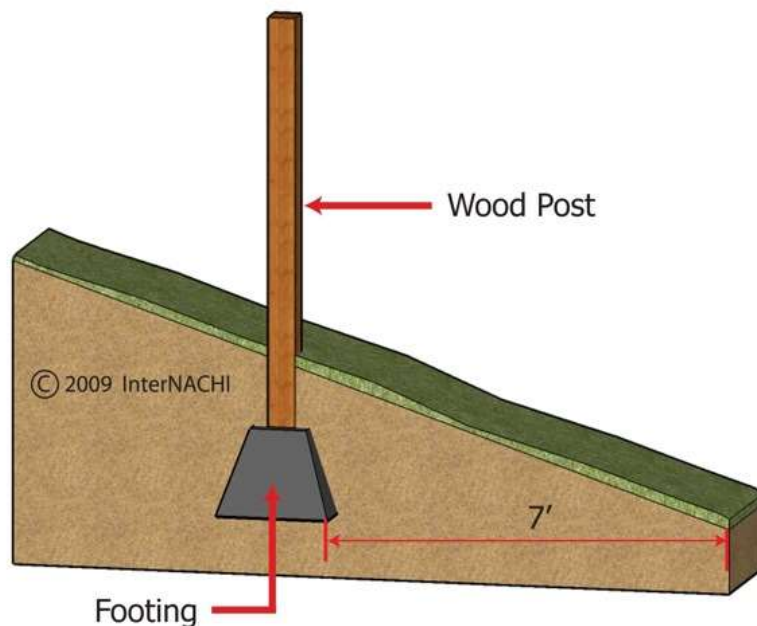
The above image depicts the *7-Foot Rule*. On steep properties, the slope of the ground around the footing could affect the footing's stability. The *7-Foot Rule* states that there should be a least 7 feet between the bottom of a footing and daylight.

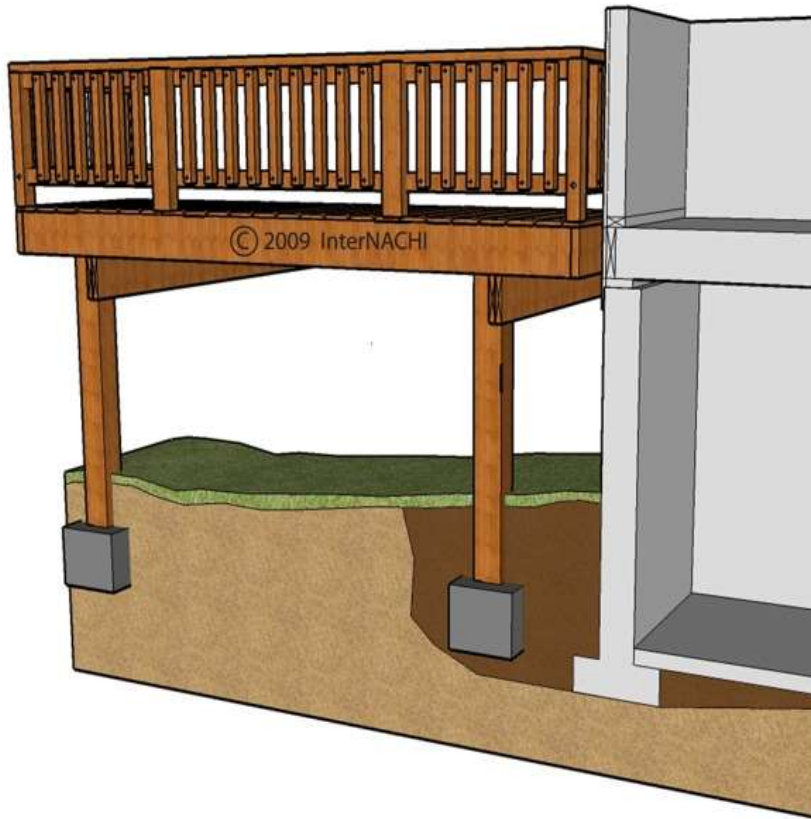
The image above depicts a free-standing deck (not attached to the home or building). A footing near a home must be on undisturbed soil. Some codes consider soil to be "undisturbed" if it hasn't been disturbed in more than five years. It may be difficult to find undisturbed soil near the foundation of a new home.

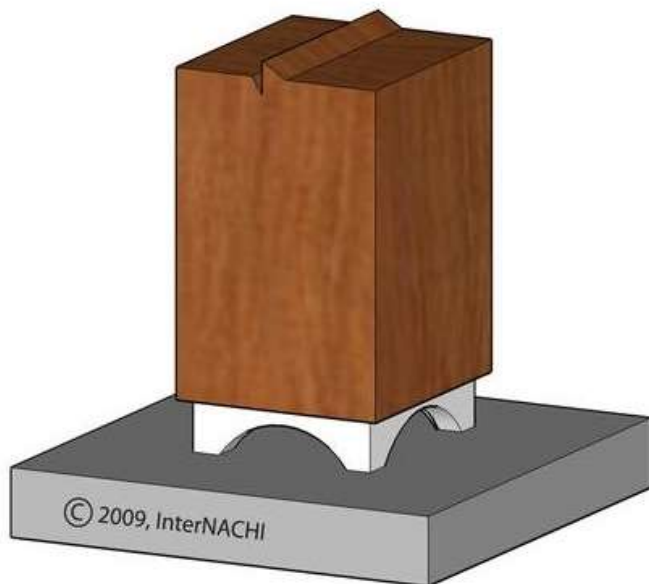
The image above depicts a post base that is not attached to its footing. Posts should be connected to their footings so that the posts don't lift or slip off.

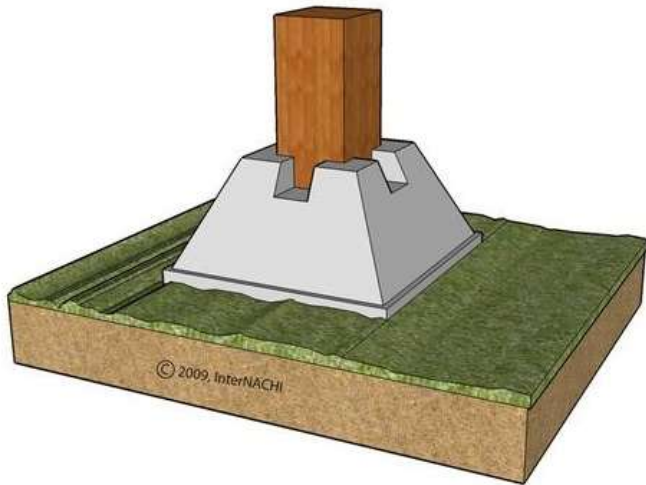
The image above depicts a pre-cast concrete pier. Posts can lift out of pre-cast concrete piers, and piers can slide. Posts should be connected to their footings so that the posts don't lift or slip off.

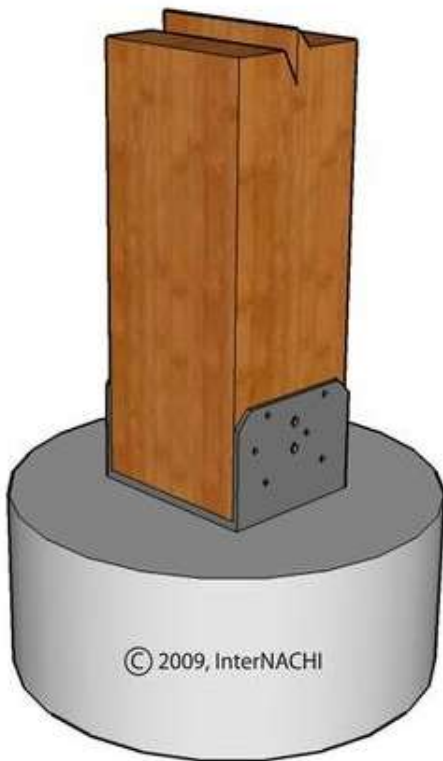
The image above depicts a proper post-to-footing connection. Posts should be connected to their footings so that the posts don't lift or slip off their footings.

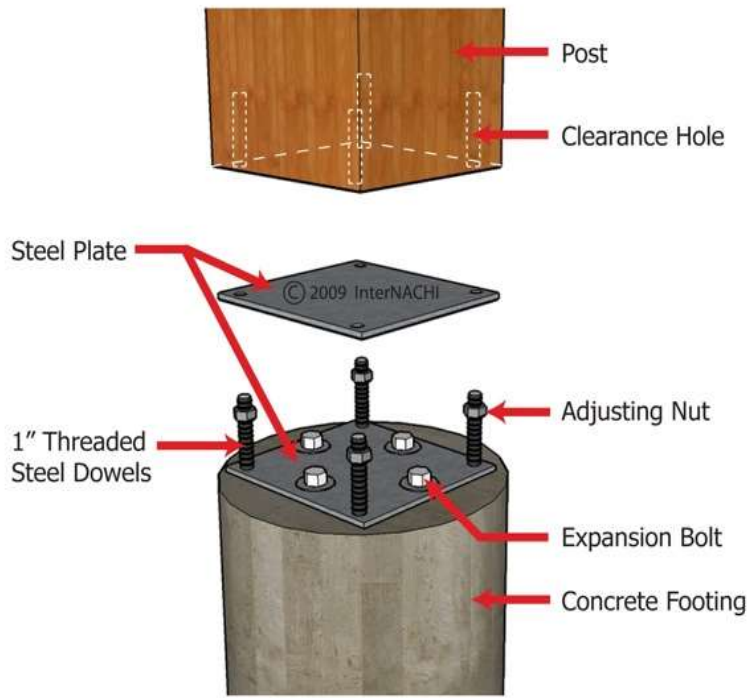
The image above depicts an adjustable post-to-footing connection. Posts should be connected to their footings so that the posts don't lift or slip off their footings.

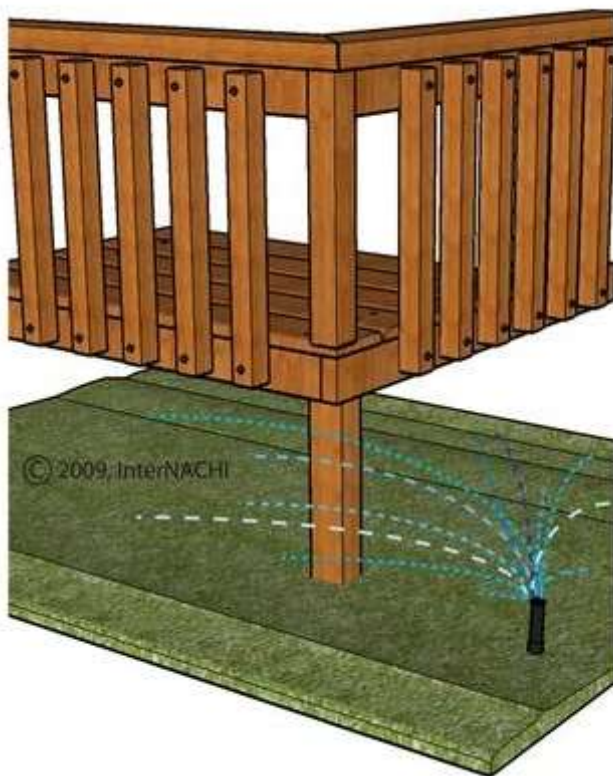
The above image depicts a lawn sprinkler keeping a deck post wet. Lawn sprinkler systems that regularly keep the deck wet contribute to decay.

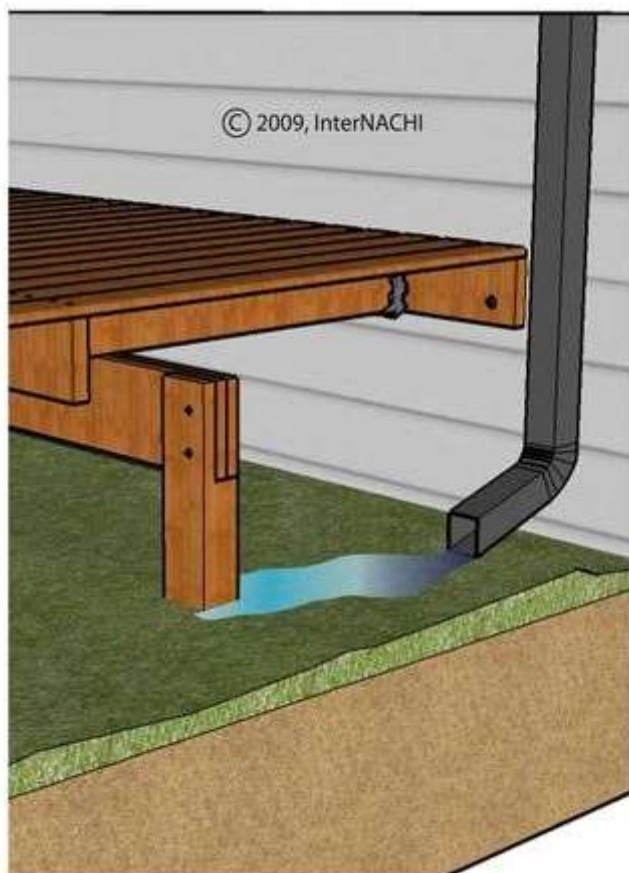
The image above depicts a downspout contributing to post decay. Downspouts should not discharge near deck posts.

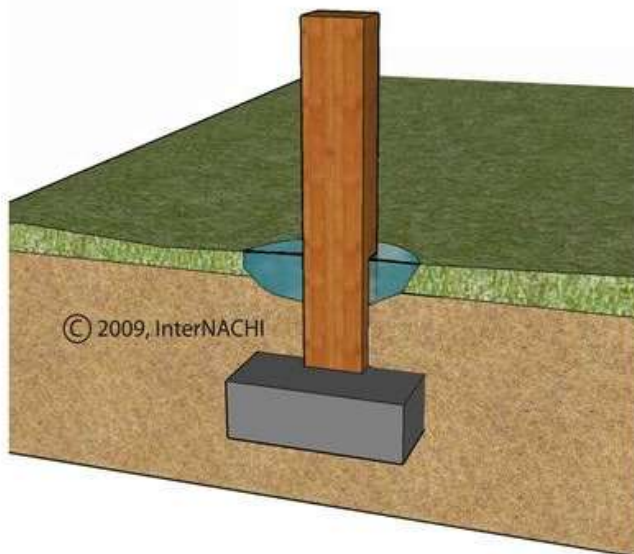
The image above depicts the indentation left over from the footing hole, causing a puddle. Puddles contribute to post decay.

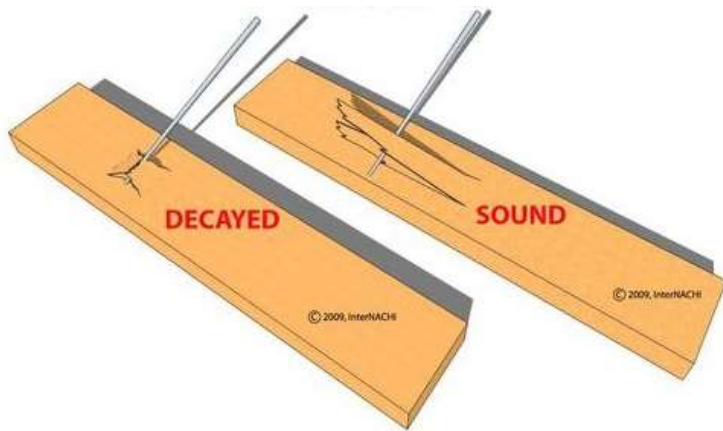
The image above depicts a "pick test." The pick test uses an ice pick, awl or screwdriver to penetrate the wood surface. After penetrating the wood, the tool is leveraged to pry up a splinter, parallel to the grain, away from the surface. The appearance and sound of the action is used to detect decay. The inspector should first try the pick test in an area where the wood is known to be sound to determine a "control" for the rest of the inspection. Decayed wood will break directly over the tool with very few splinters, and less or almost no audible noise compared to sound wood. The pick test cannot detect decay far from the surface of the wood.

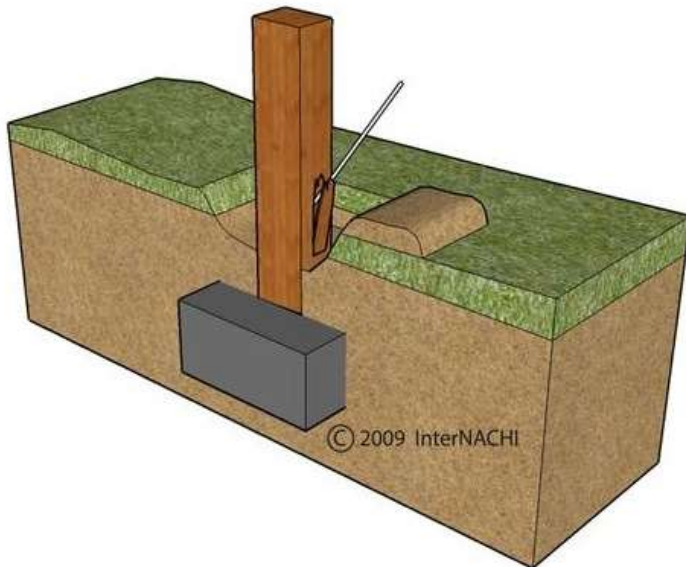
The image above depicts a pick test on a deck post. Although deck inspections are visual-only inspections, inspectors may want to dig down around posts and perform pick tests just below grade level to look for decay.

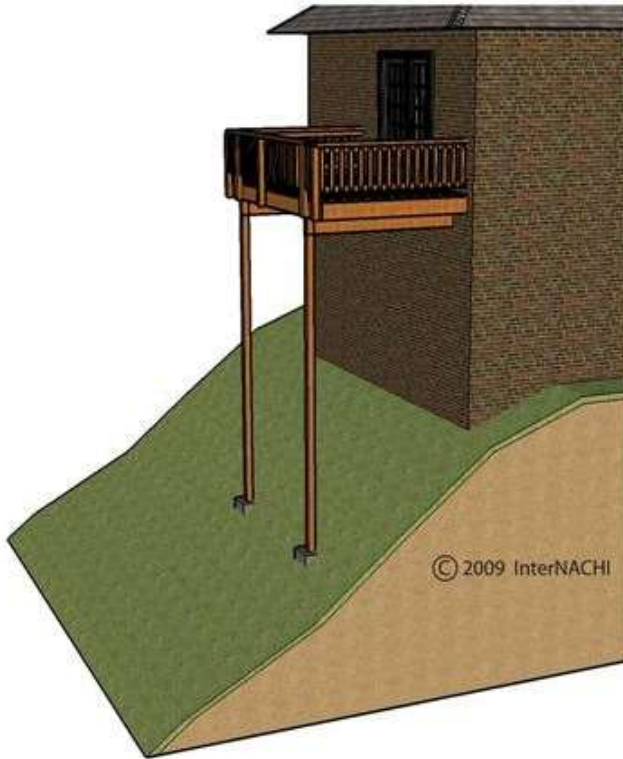
The image above depicts a high deck being supported with 4"x 4" posts. Tall 4"x 4" posts twist under load and 4"x 4" posts, even when treated, decay below grade too quickly. In all but the lowest of decks, deck posts should be at least 6"x 6", and be no higher than 12 feet; 14 feet is acceptable if cross-bracing is used.

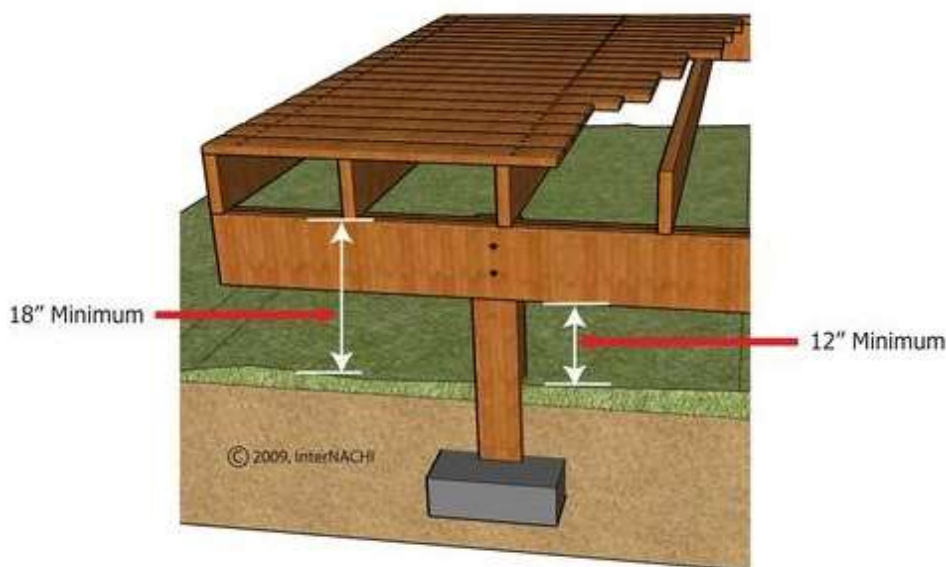
The image above depicts the minimum distance of untreated support members from grade. Untreated joists should be at least 18 inches away from the ground. Girders should be 12 inches away from the ground. However, in many situations, exceptions are made where the elevation of

the home does not provide for these minimum distances and the climate is very dry.

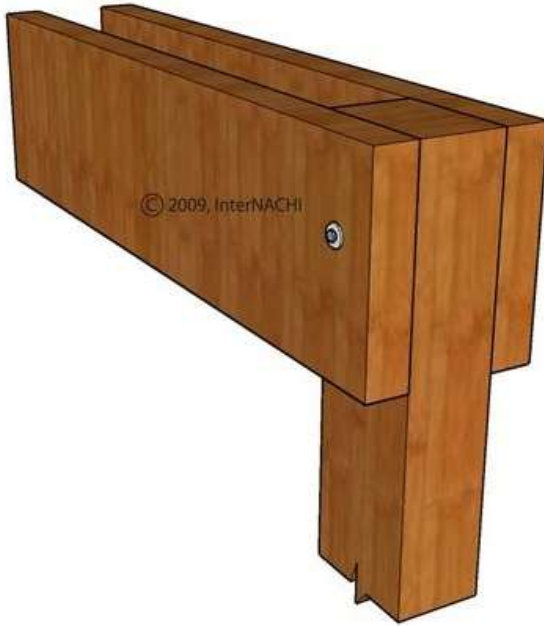
The image above depicts a girder improperly relying on the sheer strength of lag bolts. Girders should bear directly on posts.

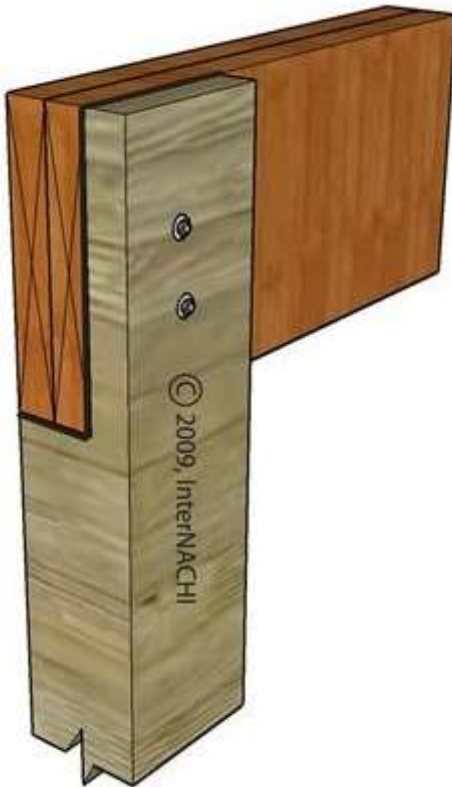
The image above depicts a girder properly resting on a notched post. Girders should bear directly on posts.

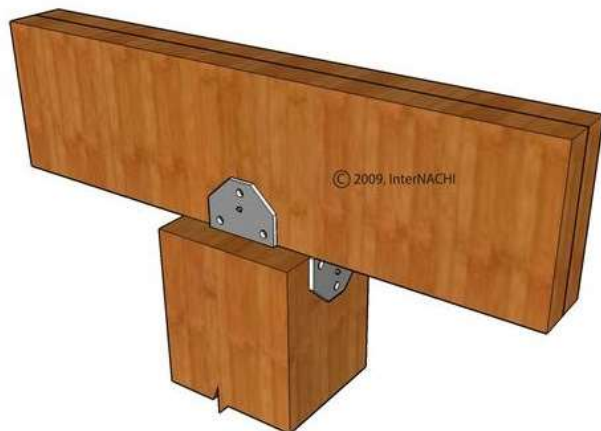
The image above depicts a girder properly resting on a post. Girders should bear directly on posts.

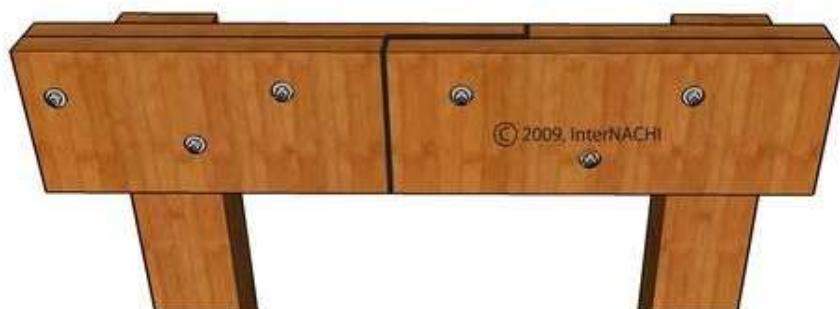
The image above depicts a butt joint improperly located within a girder span. Butt joints in a girder span are generally not permitted unless specially engineered. Butt joints typically must be located above posts.

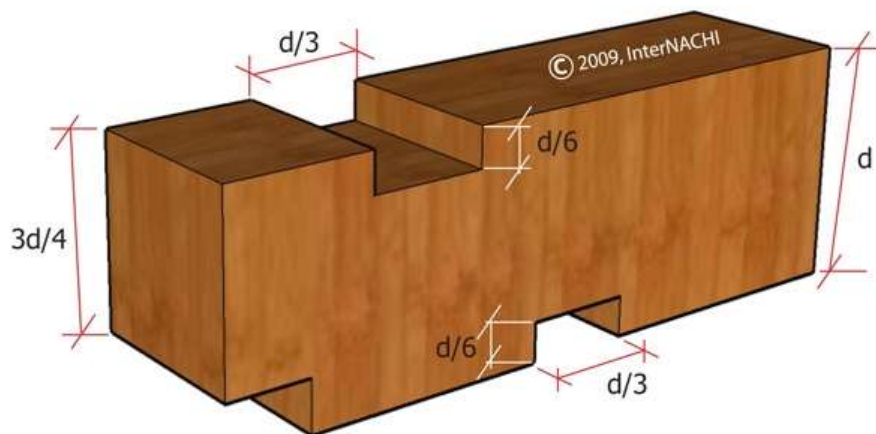
The image above depicts notches in a supporting beam. Notches must be less than one-quarter the depth of the member. On the tension and compression faces, the notch depth must be less than one-sixth of the member's depth, and the notch length must be less than one-third of the member's depth. Notches are not permitted in the middle third of spans, or on the tension face of members that are greater than 3½ inches thick.

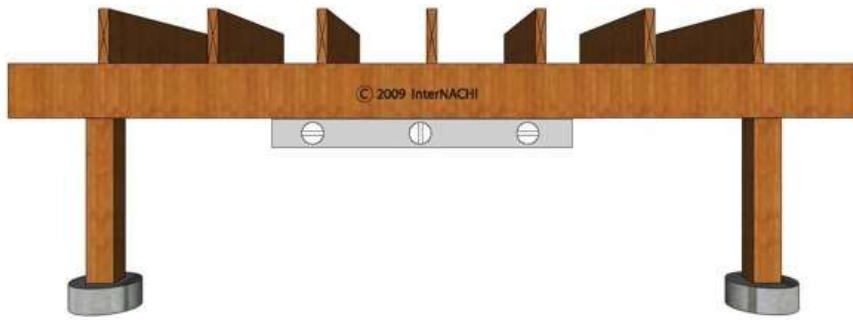
The image above depicts a level being used to check for beam sag. Even with a carpenter's level, it can be difficult to see beam sag from the front.

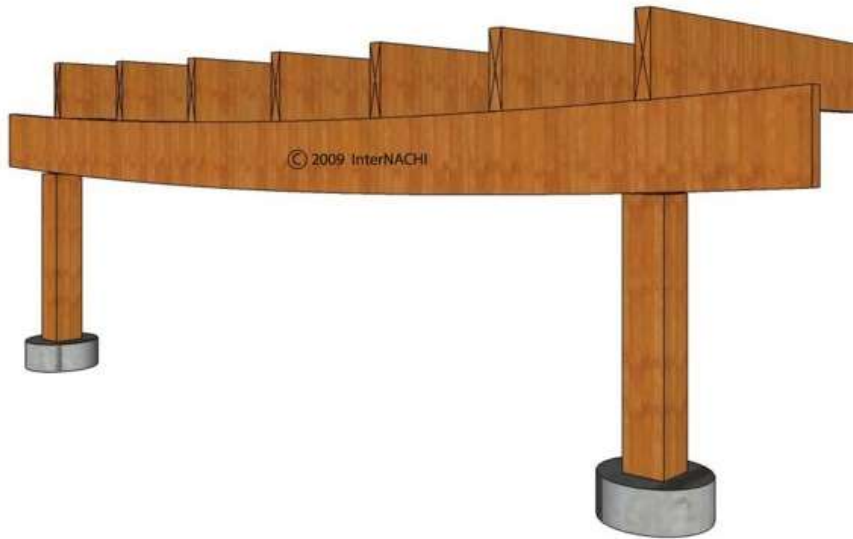
The image above depicts beam sag being eyed-up. Often it is easier to detect beam sag by eye than with a level by looking along the bottom edge of the beam.

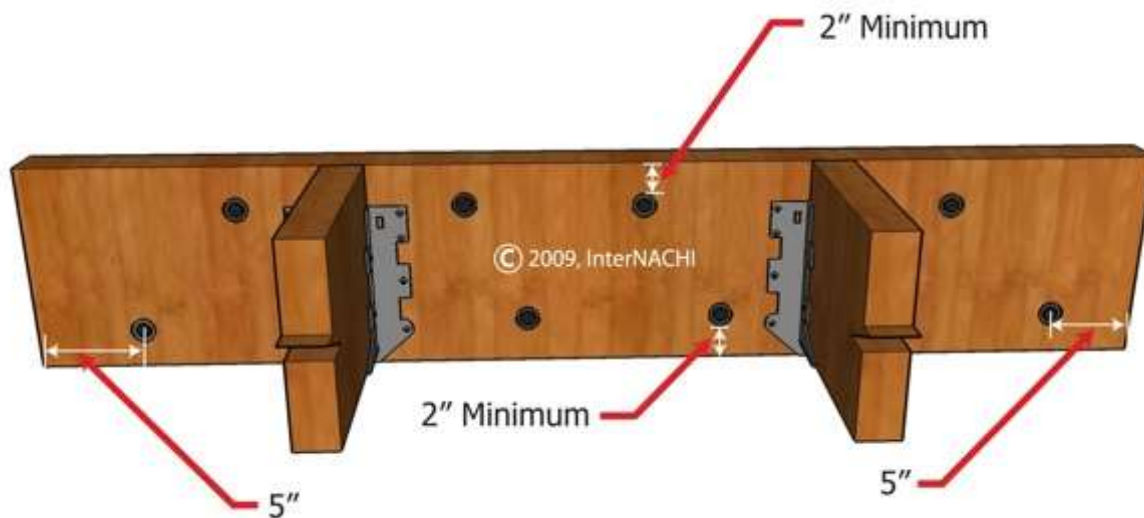
The image above shows the minimum distance of fasteners to the edges and ends of a ledger board. Lag screws or bolts should be staggered vertically, placed at least 2 inches from the bottom or top, and 5 inches from the ends of the ledger board. Some codes permit the lag screws or bolts to be as close as 2 inches from the ends of the ledger board; however, avoiding the very ends of the ledger boards minimizes splitting from load stress.

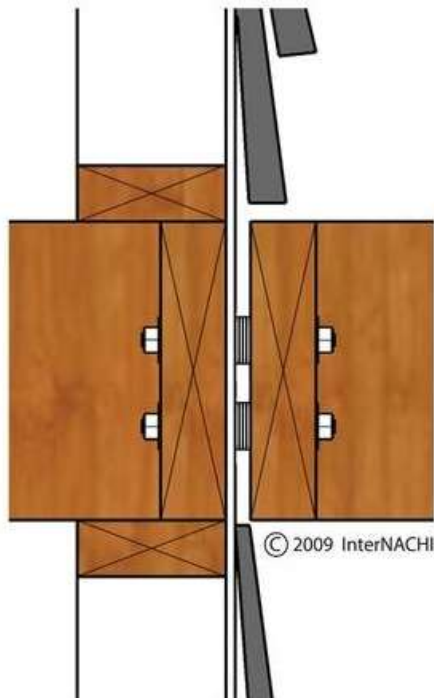
The image above depicts washers being used as spacers between the ledger board and band joist, which is incorrect.

In some cases, the ledger board and band joist are intentionally kept separated by a stack of washers on the lag screw or bolts to allow water to run between the two boards. In other cases, there is insulation between the two boards. Even worse is when the siding or exterior finish system was not removed prior to the installation of the ledger board. Situations like this, where the ledger board and band joist are not in direct contact, significantly reduce the strength of the ledger connection to the structure and are not recommended by InterNACHI, unless the two members are sandwiching structural sheathing.

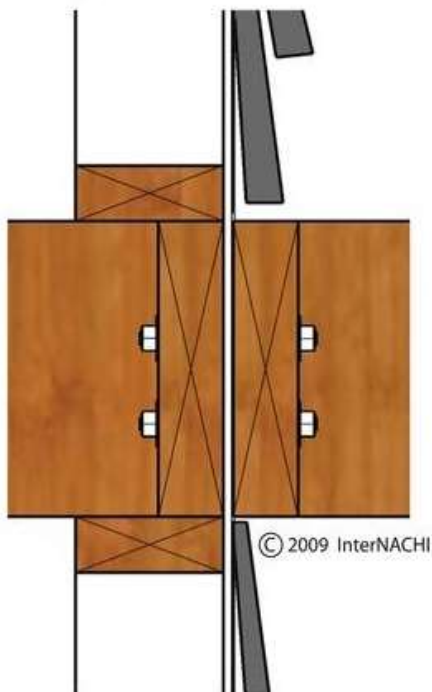
The image above depicts a ledger board and band joist sandwiching the structural sheathing

(correct).

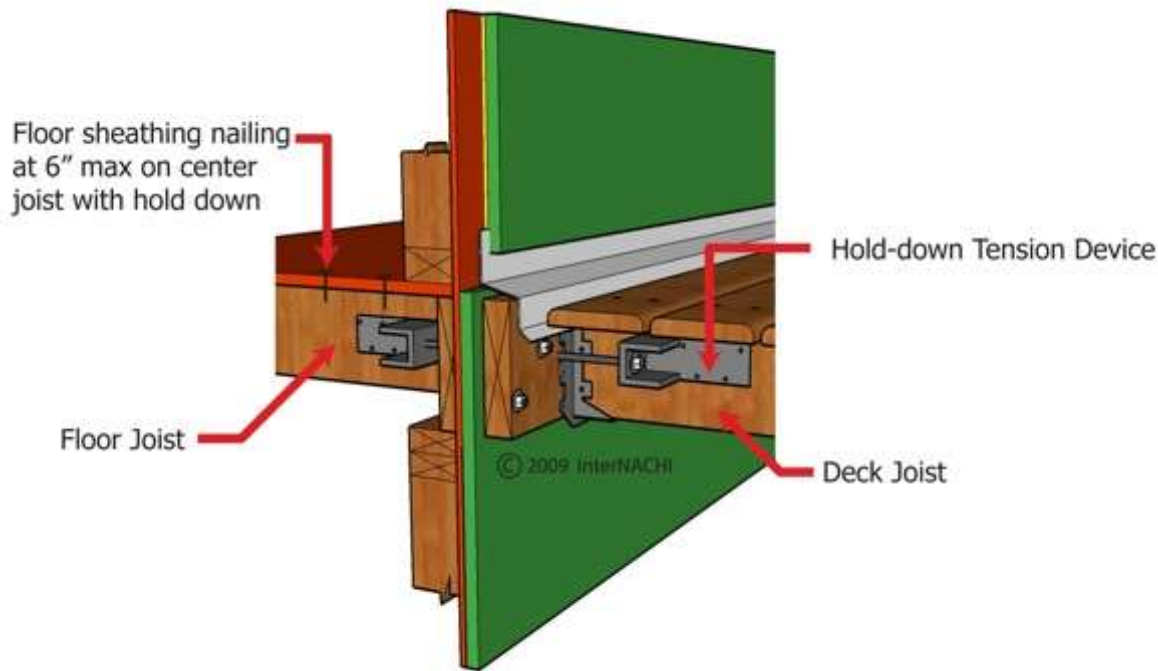
The image above depicts a hold-down tension device. The *2007 IRC Supplement* requires hold-down tension devices at no less than two locations per deck.

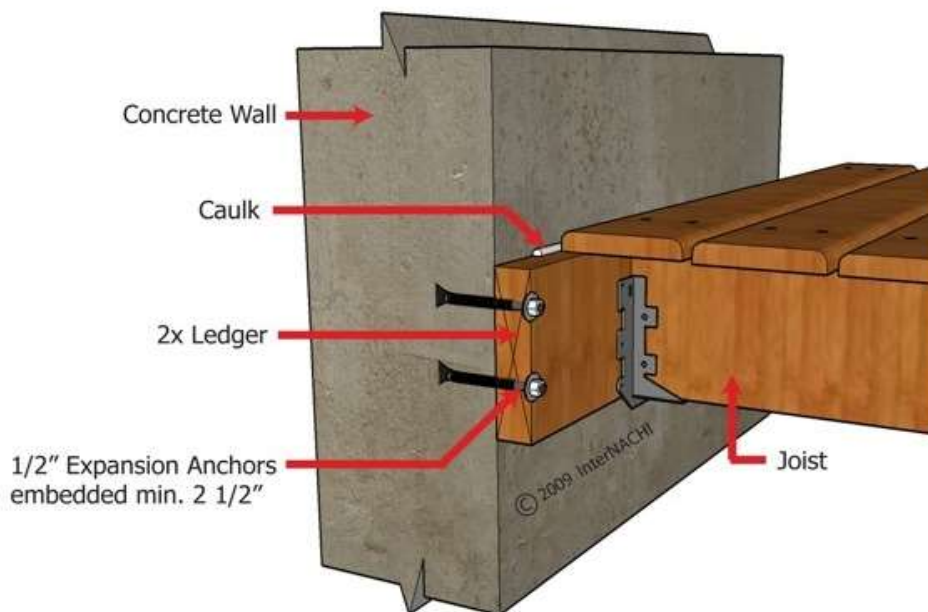
The image above depicts a ledger board attached to a concrete wall. Caulking rather than flashing is used.

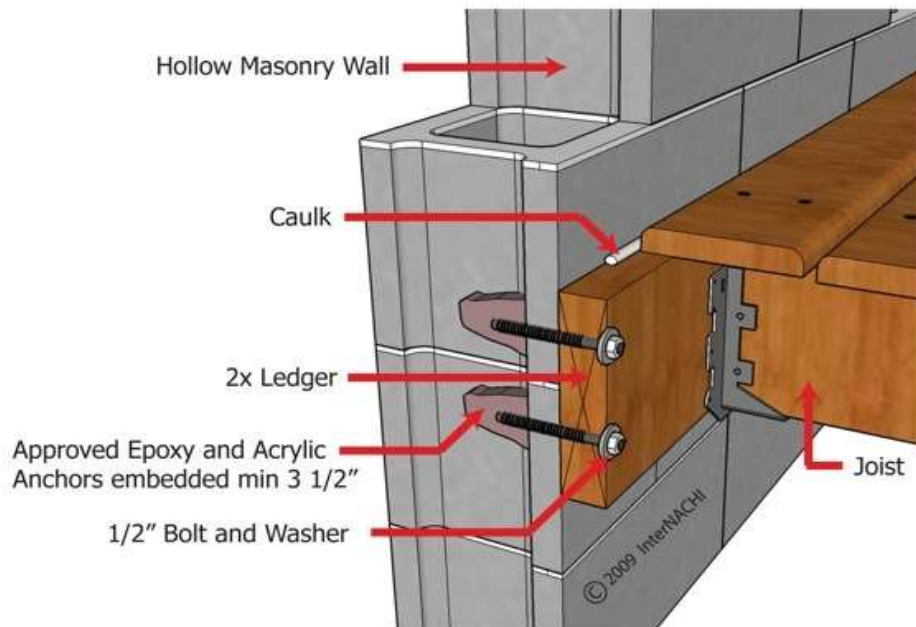
The image above depicts a ledger board attached to hollow masonry. When the ledger is attached to a hollow masonry wall, the cell should be grouted.

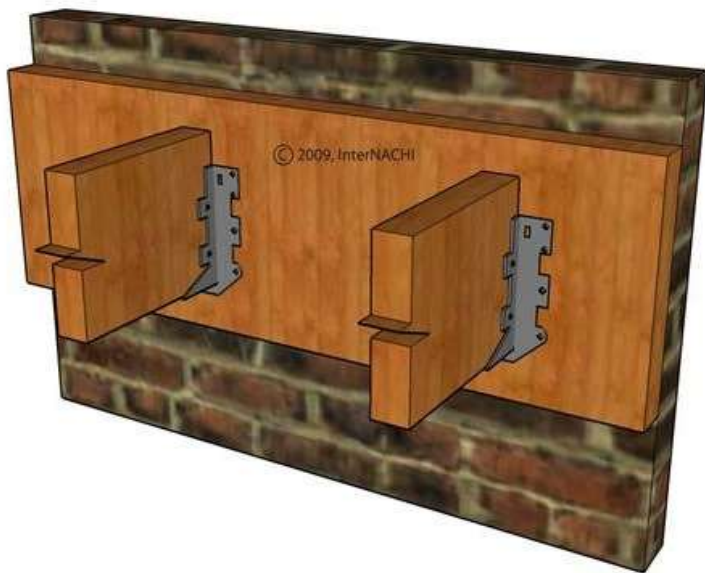
The image above depicts a ledger board improperly supported brick veneer. Ledger boards should not be supported by stone or brick veneer.

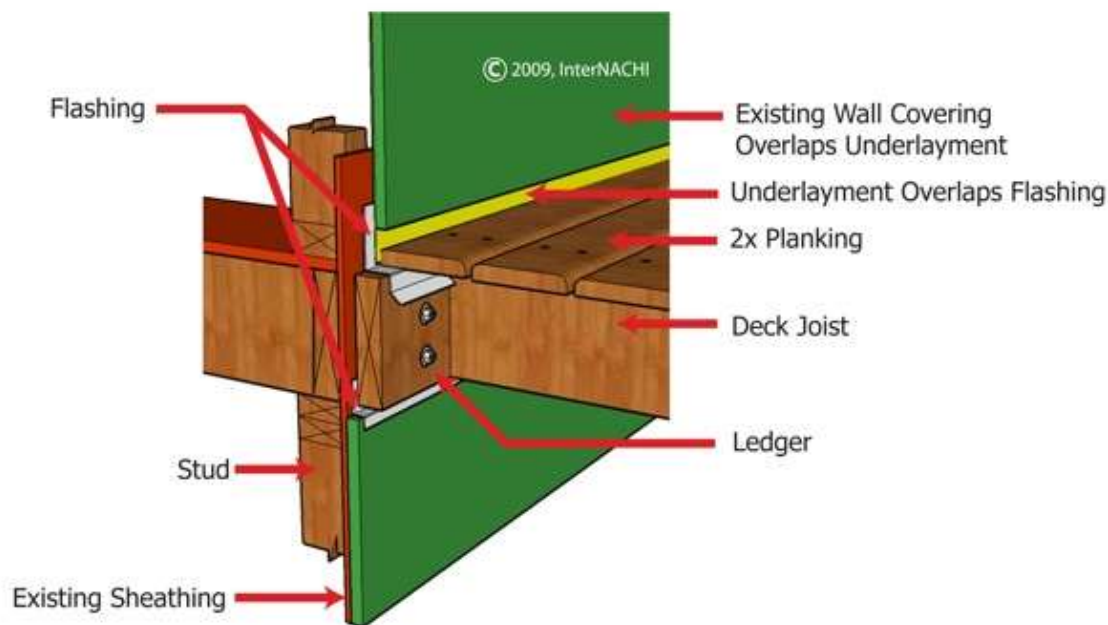
The image above depicts both over and under ledger board flashing. The ledger board should always be flashed even when the home or building has a protective roof overhang.

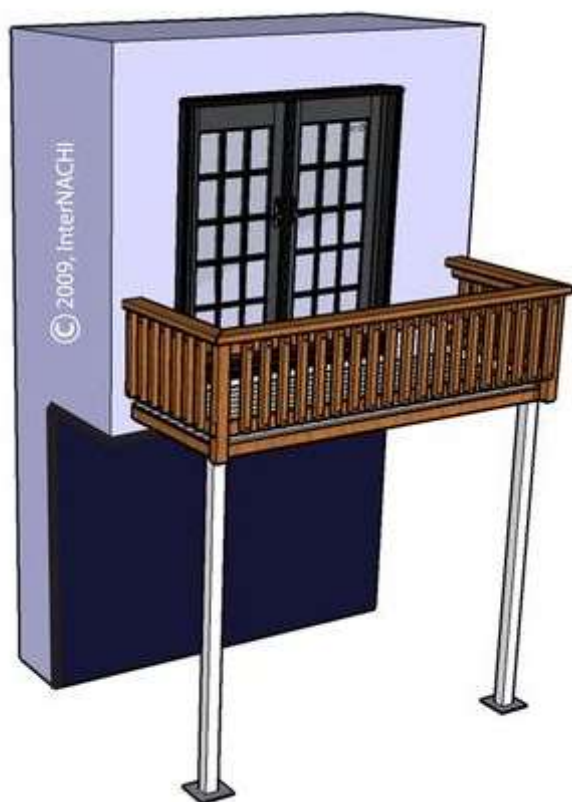
The image above depicts a deck ledger attached to an overhang. Decks should not be attached to overhangs.

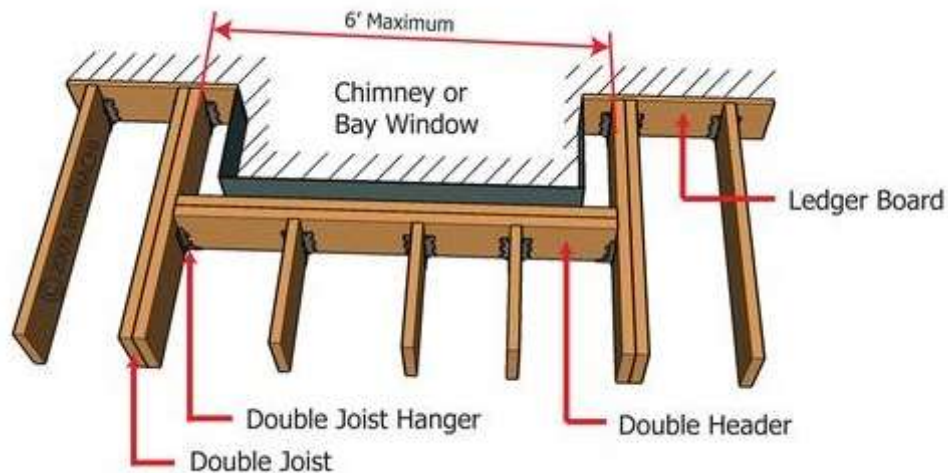
The image above depicts proper framing around chimneys or bay windows that are up to 6 feet wide. Framing around chimneys or bay windows that are more than 6 feet wide requires additional posts.

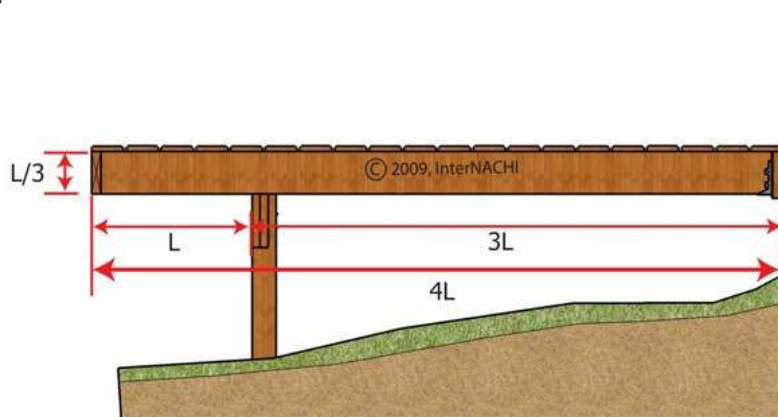
The image above depicts a cantilevered deck. Joists should be cantilevered no more than one-quarter of the joist length and three times the joist width (nominal depth). Both conditions must be true.

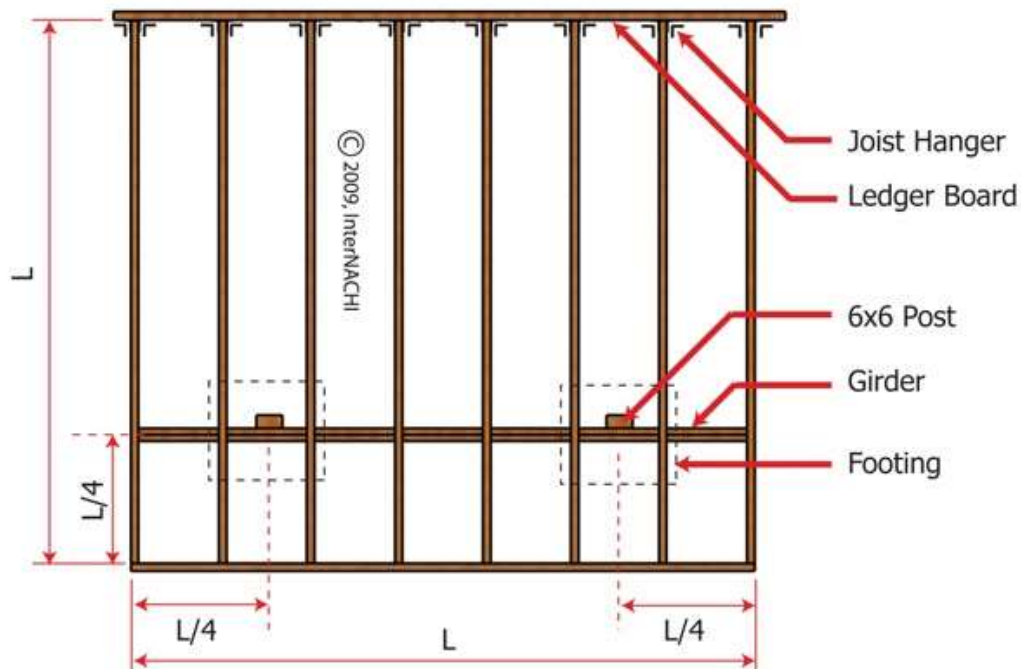
The image above depicts a joist cantilever in the front of the deck and girder cantilevers on both sides of deck posts. Joists should be cantilevered no more than one-quarter the joist length and three times the joist width (nominal depth). Girders can be cantilevered over their posts no more than on-quarter the girder length.

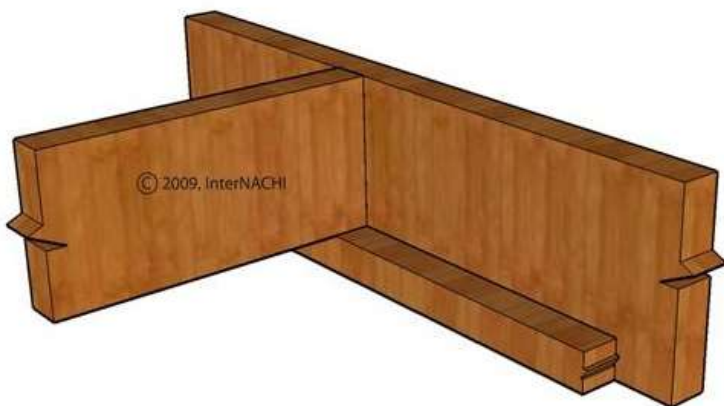
The first is by resting the joist on a ledger strip. The image above depicts a joist properly resting on a 2"x2" ledger strip.

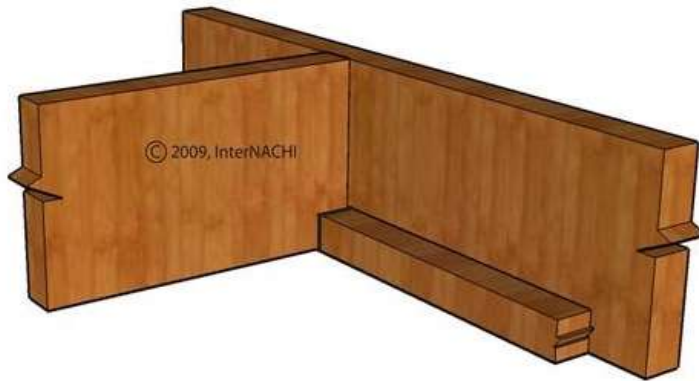
The second is by notching over a ledger strip. The image above depicts a notched joist properly resting a 2"x 2" ledger strip.

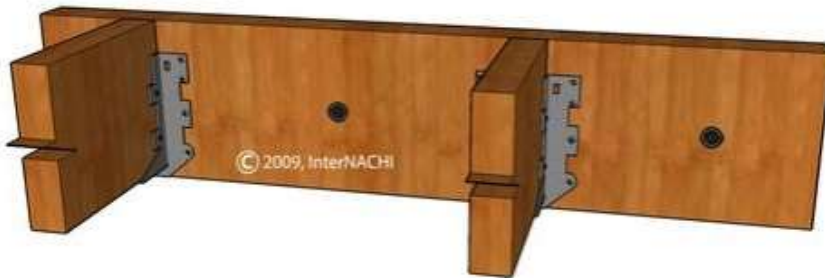
The third is by hanging the joists with joist hangers. The image above depicts joists properly attached to a ledger by way of metal joist hangers.

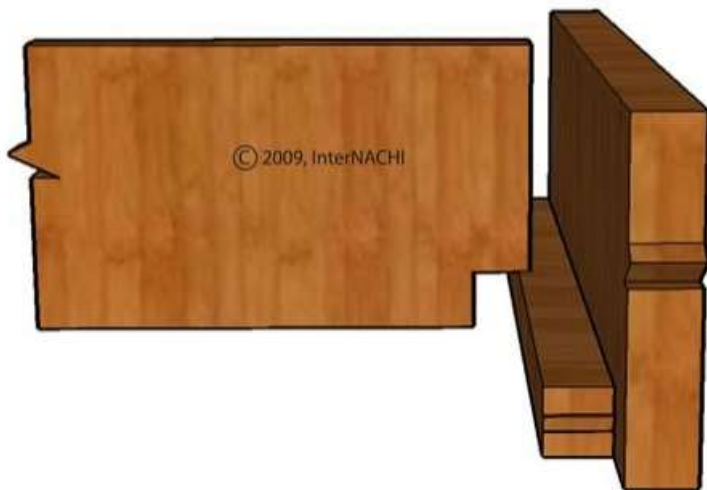
The image above depicts a joist cut too short. Joists may rest on 2"x 2" ledgers like the one above (or in joist hangers), but joists must be cut long enough to reach the ledger or band joist that is supporting them.

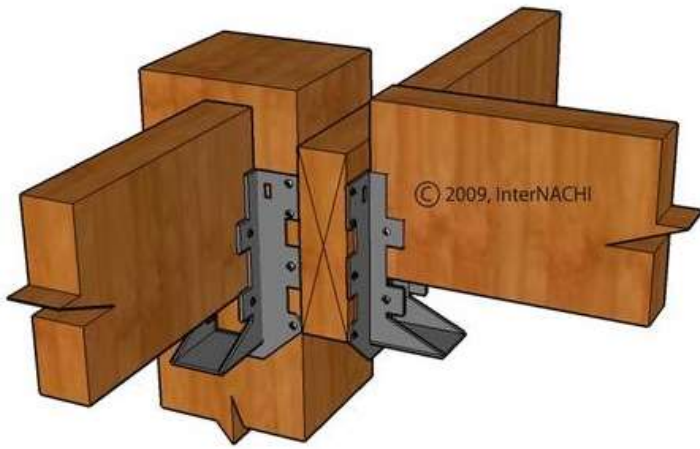
The image above depicts joists that are not fully resting in their joist hangers. Joists should be fully resting in their joist hangers.

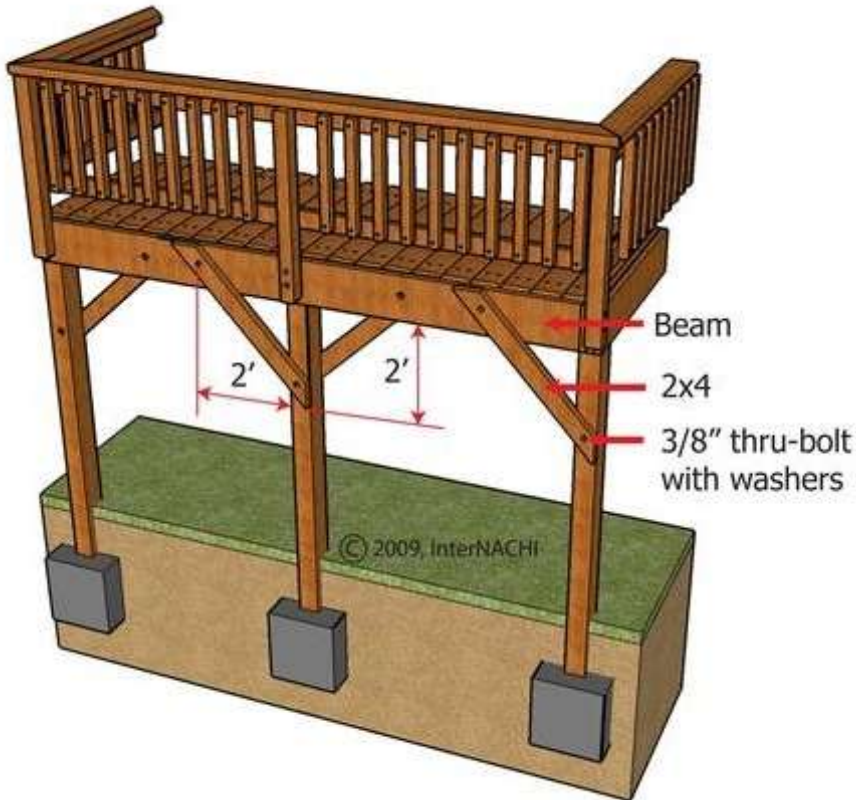
The image above depicts a deck with post-to-joist diagonal bracing. Decks greater than 6 feet above grade should have diagonal bracing from posts to girder, and from posts to joists.

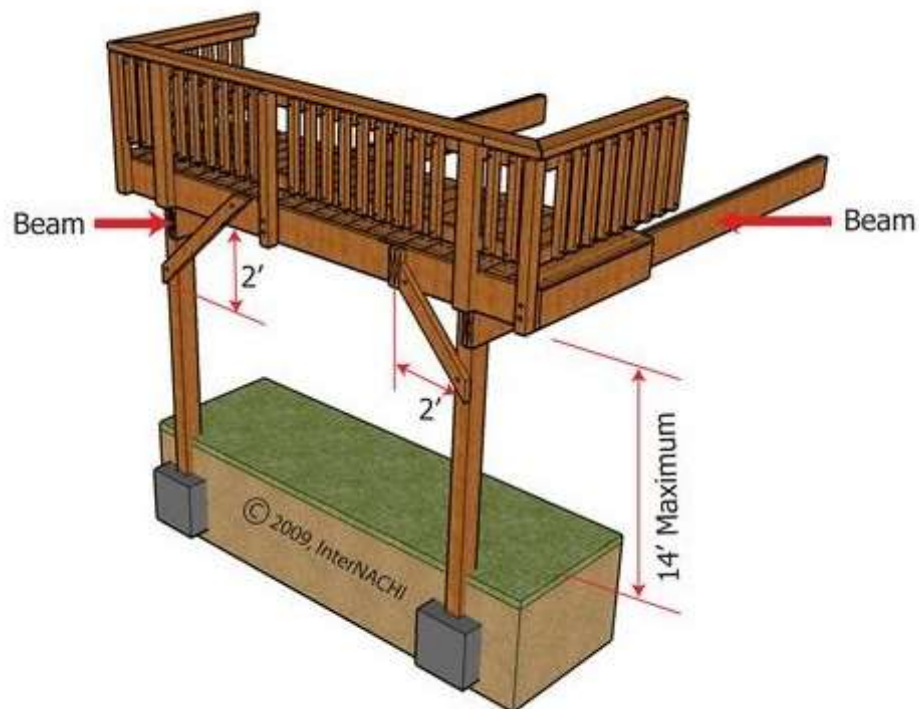
The image above depicts a deck with post-to-girder diagonal bracing. Decks greater than 6 feet above grade should have diagonal bracing from posts to girder, and from posts to joists.

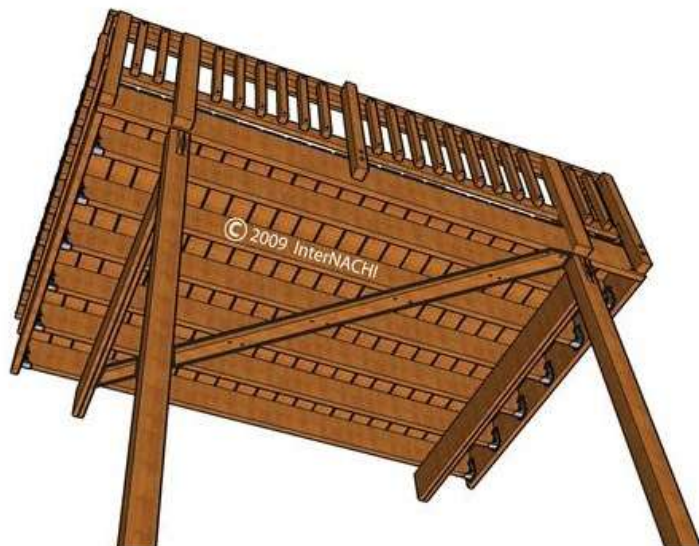
The image above depicts underside diagonal bracing of a deck. Decks greater than 6 feet above grade that do not have diagonal decking should have diagonal bracing across the bottoms of the joists to keep the deck square. A deck that is not held square could permit the outer posts to lean to the right or left, parallel to the ledger board, and thus twist the ledger away from the home or building.

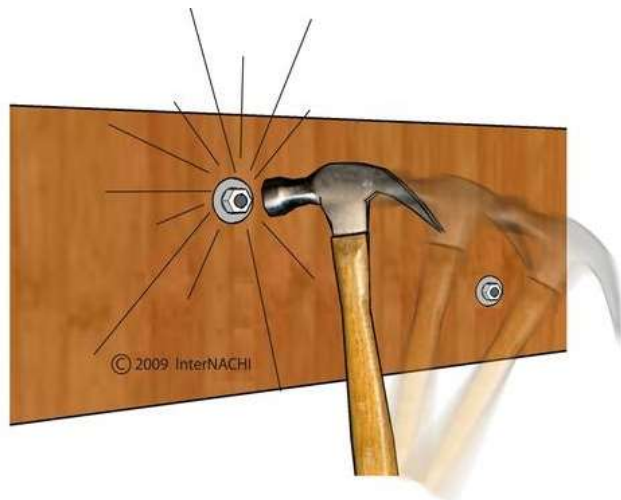
The image above depicts a "hammer test." Depending on how the deck was built, vital connections may have degraded over time due to various factors. Issues such as wobbly railings, loose stairs, and ledgers that appear to be pulling away from the adjacent structure are all causes for concern. The tightness of fasteners should be checked. If it is not possible to reach both sides of a bolt, it may be struck with a hammer. The ring will sound hollow with vibration if the fastener is loose. The ring will sound solid if the connection is tight. The hammer test is subjective, so the inspector should hammer-test bolts that can be confirmed as tight or loose, and compare the sounds of the rings to develop a control.

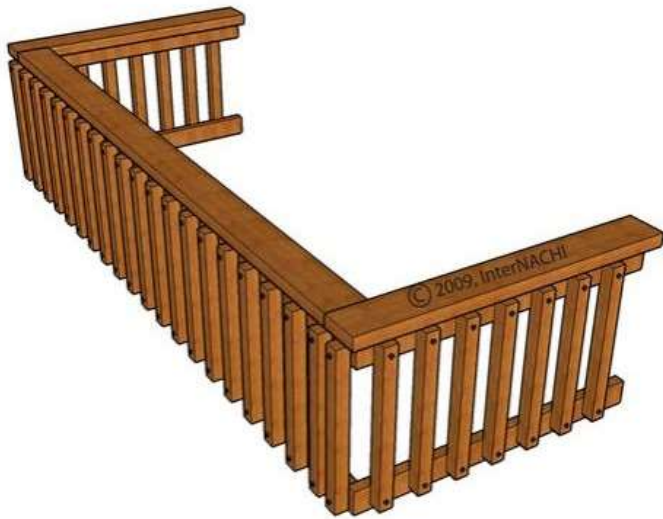
The image above shows a guardrail supported solely by balusters. Guardrails should be supported by posts every 6 feet.

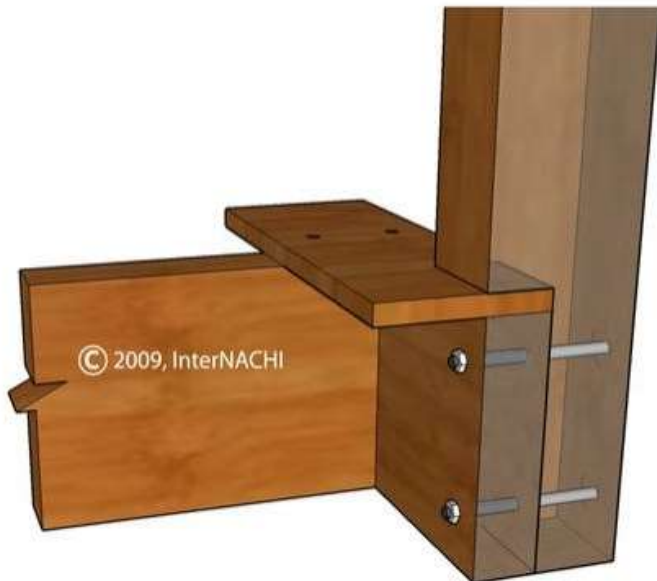
The image above depicts a notched-deck guardrail post attachment. This common notched-type of attachment is permitted by most codes, but could become unsafe, especially as the deck ages. Because of leverage, a 200-pound force pushing the deck's guardrail outward causes a 1,700-pound force at the upper bolt attaching the post. It is difficult to attach deck guardrail posts in a manner that is strong enough without using deck guardrail post brackets.

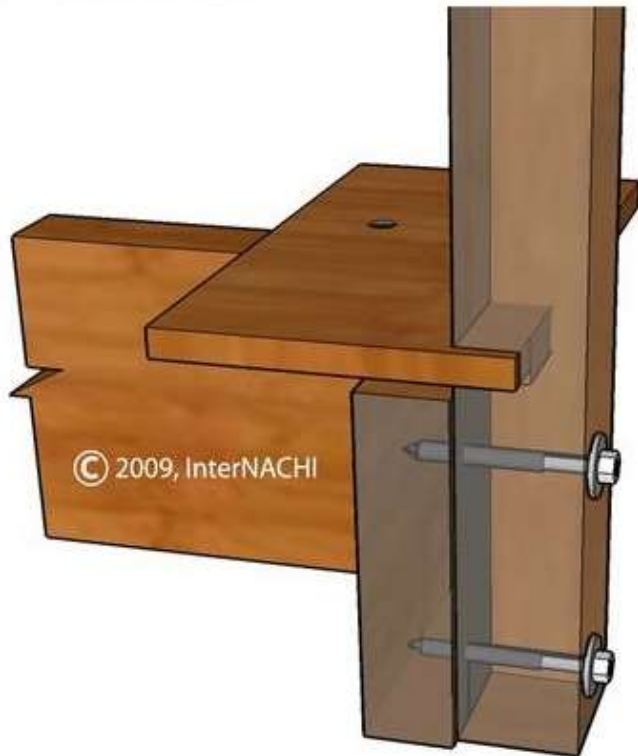
The image above depicts a notched-deck guardrail post attachment. This notched-around-decking type of attachment is permitted by most codes, but could become unsafe, especially as the deck ages. Because of leverage, a 200-pound force pushing the deck's guardrail outward causes a 1,700-pound force at the upper bolt attaching the post. It is difficult to attach deck guardrail posts in a manner that is strong enough without using deck guardrail post brackets.
