Inspecting a Deck, Illustrated

by Nick Gromicko, Founder, International Association of Certified Home Inspectors (InterNACHI)
Graphics by InterNACHI's Lisaira Vega

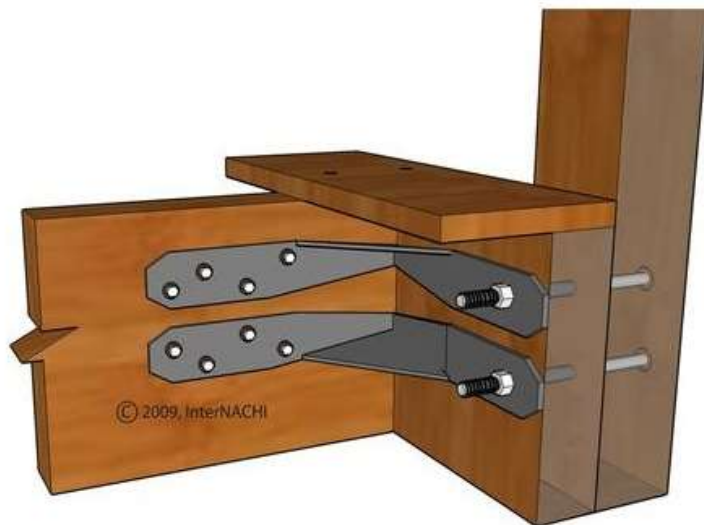
The image above depicts a deck guardrail post properly attached with brackets. Because of leverage, a 200-pound force pushing the deck's guardrail outward causes a 1,700-pound force at the upper bolt attaching the post. It is difficult to attach deck guardrail posts in a manner that is strong enough without using deck guardrail post brackets.

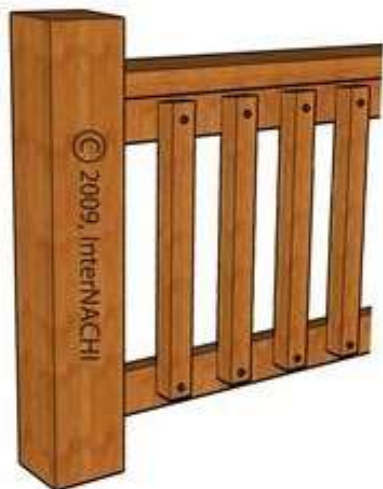
The image above depicts a post and balusters cut level and not shedding water. The end-grain of vertical posts and balusters should not be cut level.

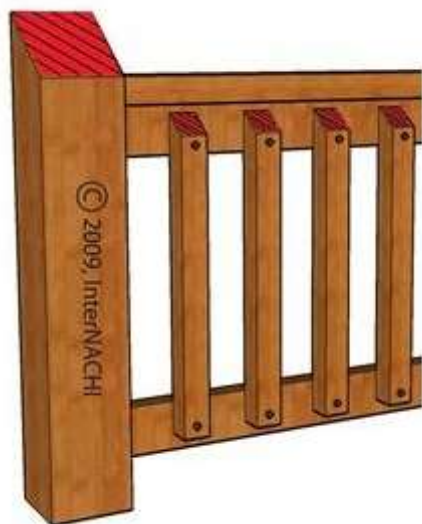
The image above depicts a post and balusters properly cut at angles to shed water. The end-grain of vertical posts and balusters should be cut at an angle.

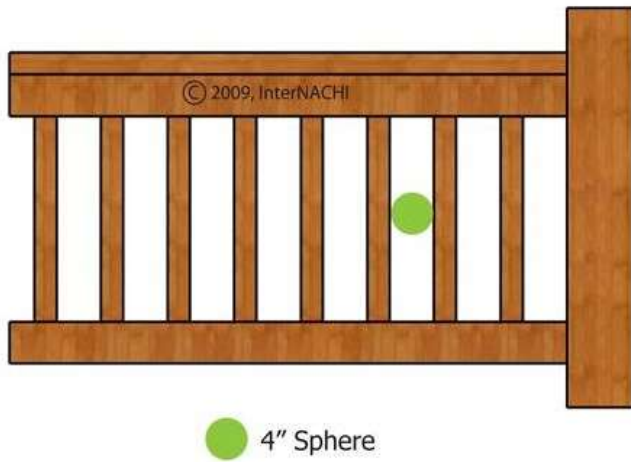
The image above depicts child-unsafe guardrail infill. Infill should not permit a 4-inch sphere to pass through.

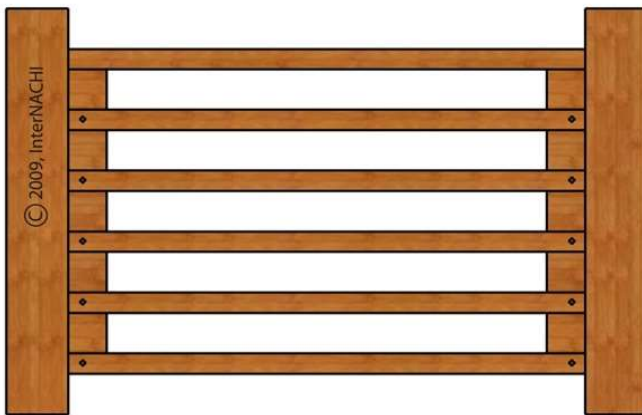
The image above depicts horizontal balustrades. Ladder-type guardrail infill on high decks is prohibited by some local codes because they are easy for children to climb over.

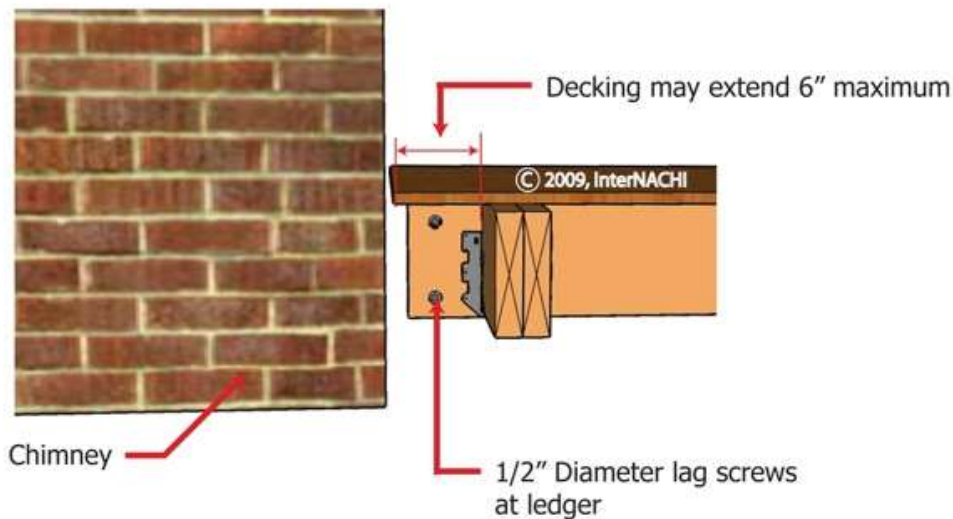
The image above depicts deck framing near a chimney or bay window. The ends of decking boards near the chimney or bay window can extend unsupported up to 6 inches.

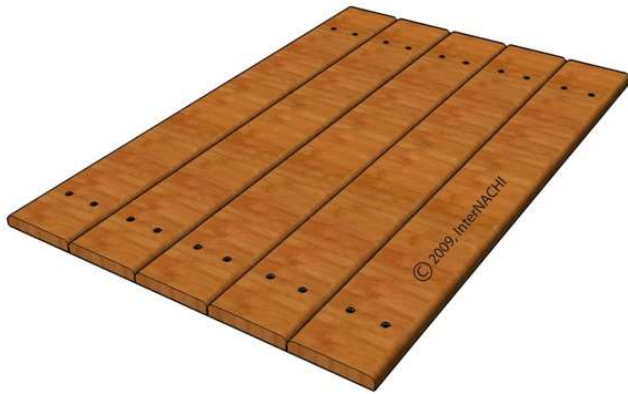
The above image depicts decking that is laid too tight. Decking should have 1/8-inch gaps between boards so that puddles don't form.

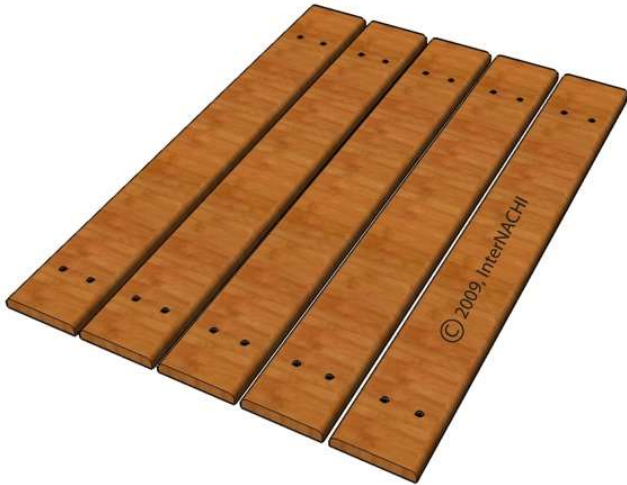
The above image depicts decking that is properly spaced. Decking should have 1/8-inch gaps between boards so that puddles don't form.

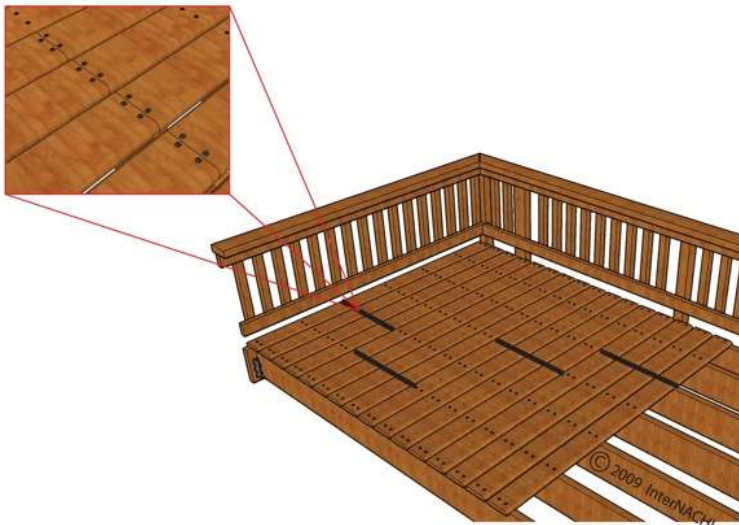
The image above depicts decking that isn't staggered properly. Decking should be staggered so that butt joints don't land on the same joist side by side.

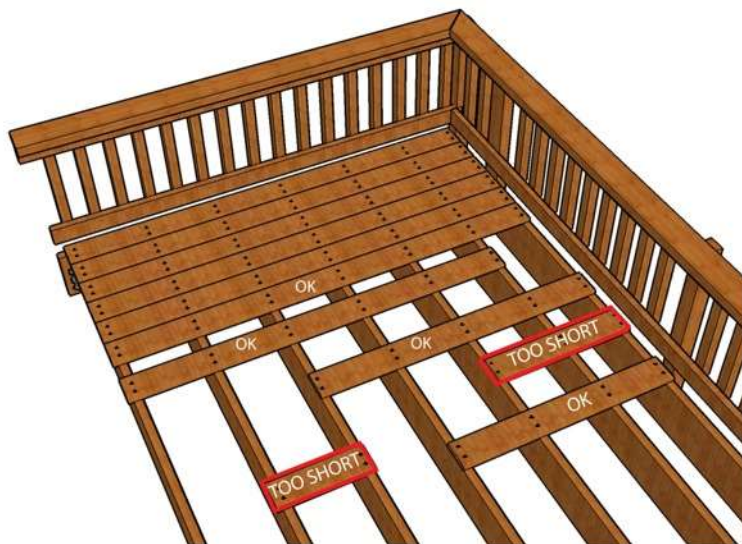
The image above depicts decking lengths. Some are too short. Each segment of decking should bear on a minimum of four joists.

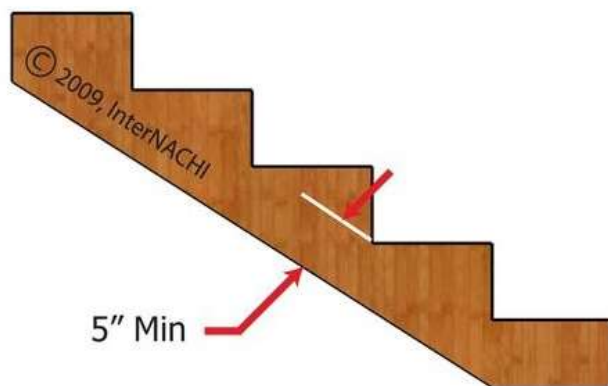
The image above depicts a deck stair stringer. Stair stringers shall be made of 2"x 12" lumber at a minimum, and no less than 5 inches wide at any point.

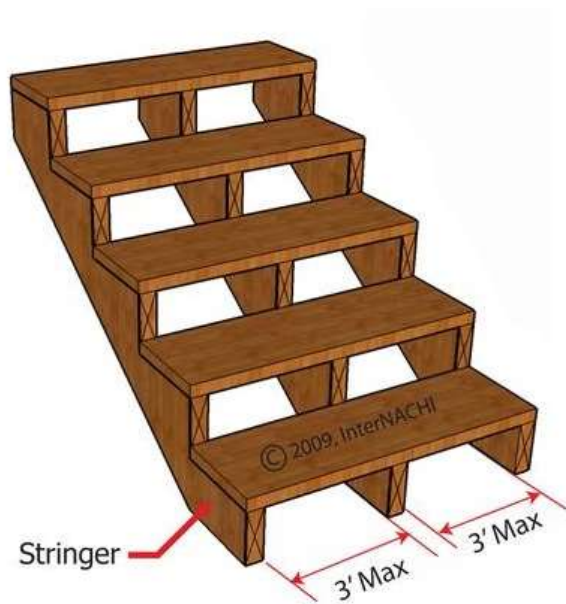
The image above depicts deck stair stringers. Stringers should be no more than 36 inches apart.

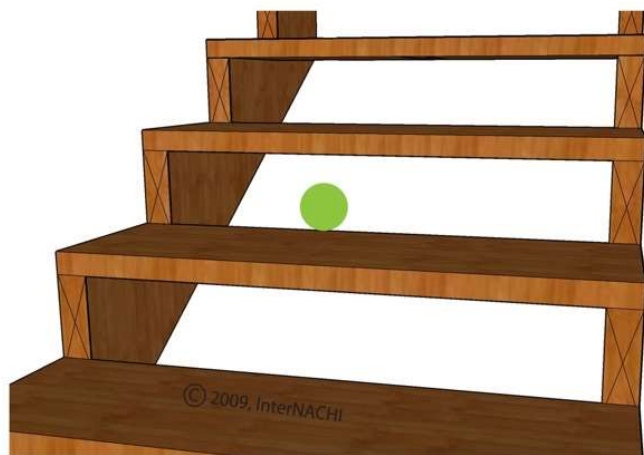
● 4" Sphere

The image above depicts a set of stairs with open risers. Most deck stairs have open risers and are not safe for children. Risers may be open but should not allow the passage of a 4-inch diameter sphere.

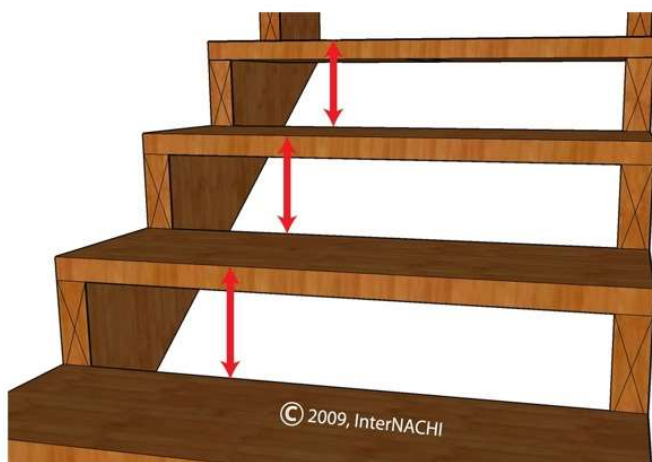
The image above depicts stair riser height. To minimize tripping, the maximum variation amongst riser heights (difference between the tallest and shortest risers) should be no more than 3/8-inch.

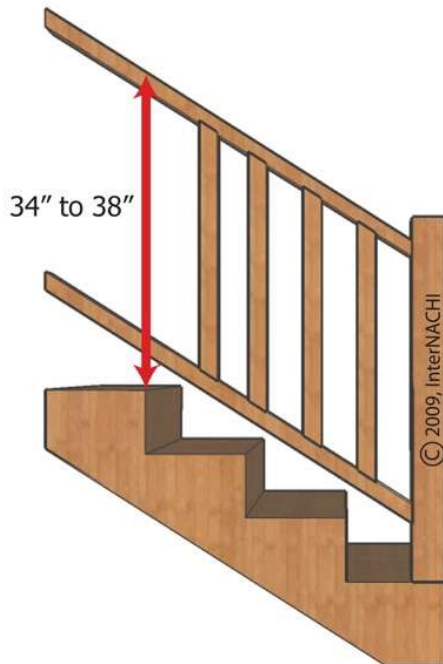
The image above depicts proper stair handrail height. Handrail height should be between 34 and 38 inches measured vertically from the sloped plane adjoining the tread nosing.

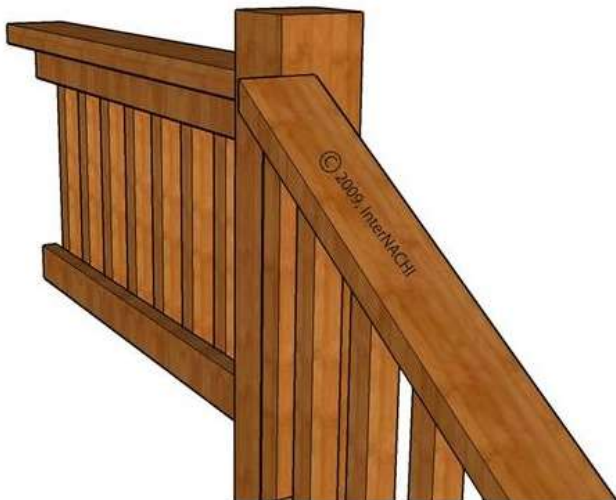
The image above depicts a stair handrail that is not graspable. Many deck handrails improperly consist of 2"x 6" lumber or decking. Handrails should be graspable, continuous and smooth.

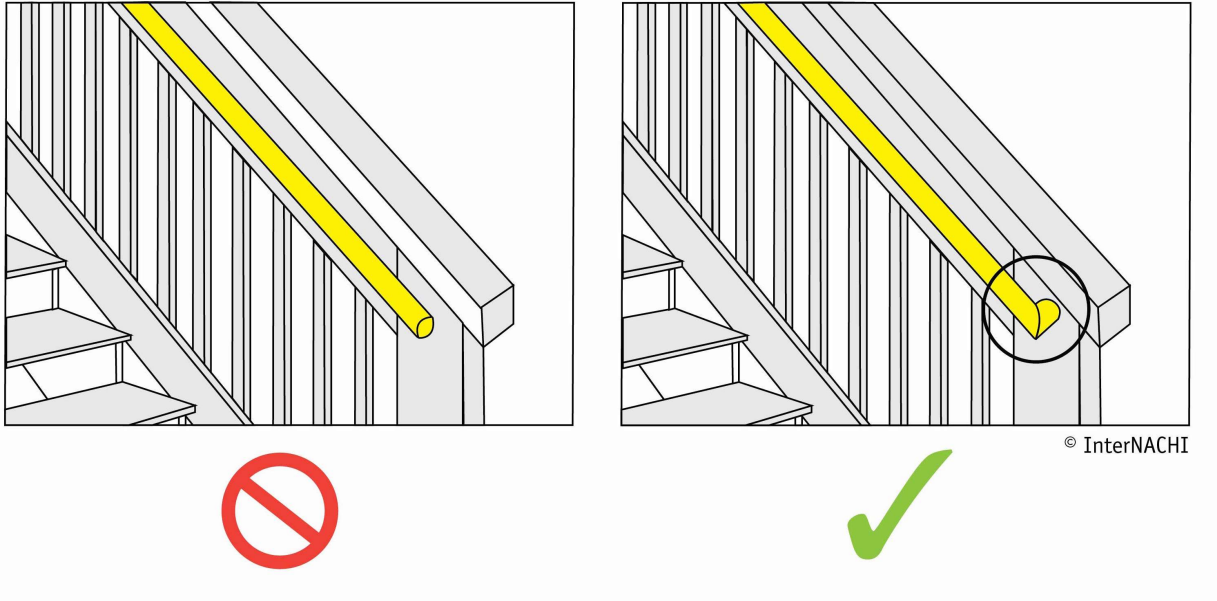
The images above show that handrail ends should be returned or terminate in newel posts.

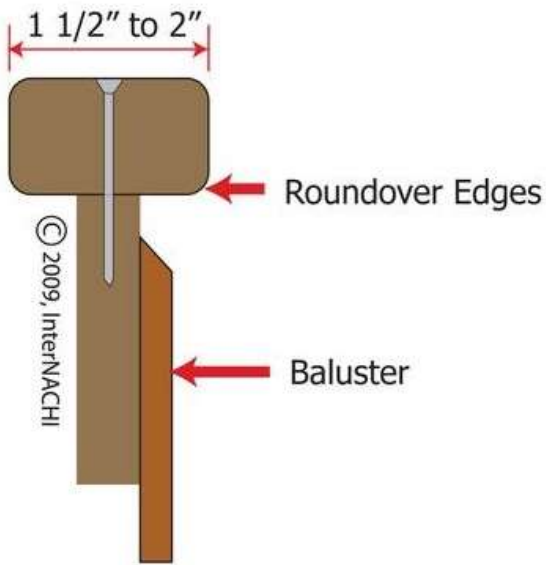
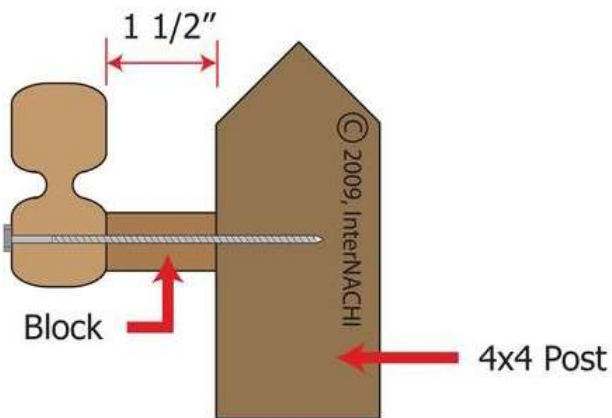
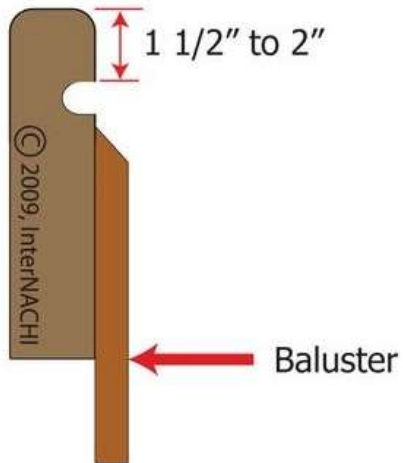
The next three images depict graspable handrails:

The three images directly above depict graspable handrails. Many deck handrails improperly consist of 2"x 6" lumber or decking. Handrails should be graspable, continuous and smooth.

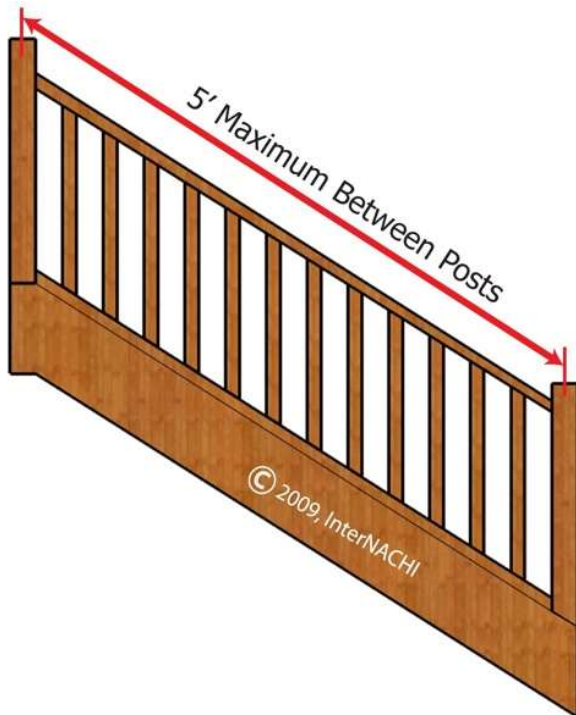
The image above depicts the minimum distance between stair handrail posts. Stair handrails should have posts at least every 5 feet.

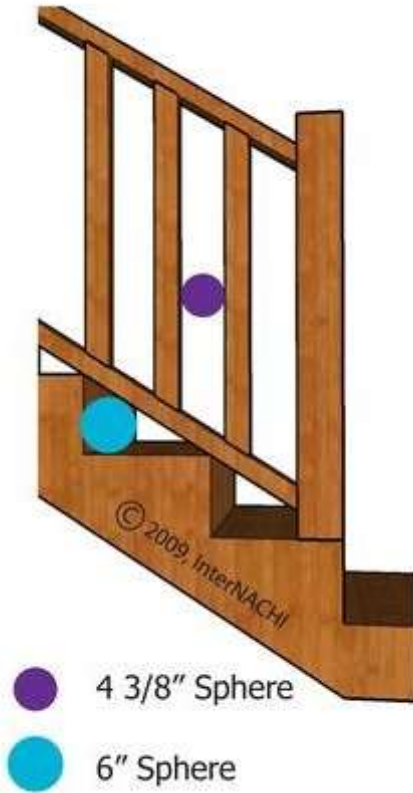
The image above depicts permitted spacing at stairs. Larger spacing presents a child-safety issue.

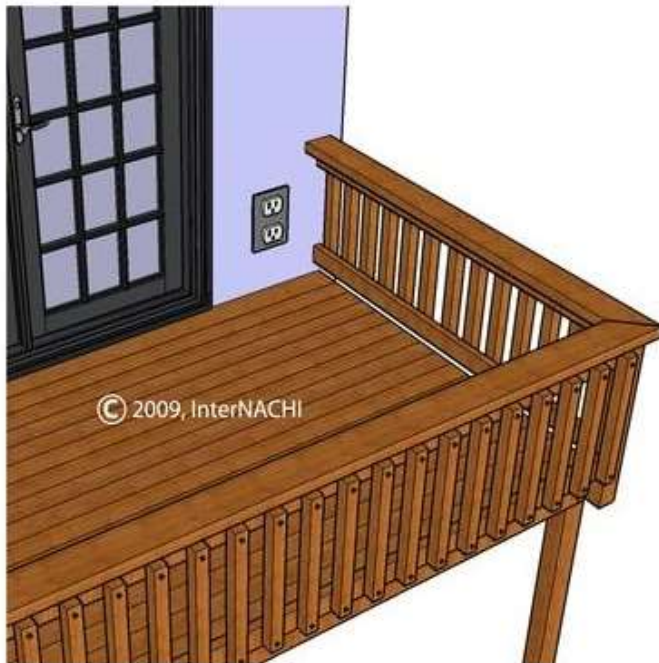
The image above depicts a deck with an electrical receptacle, but the receptacle does not have a weatherproof cover. As of 2008, the National Electric Code requires at least one receptacle outlet on decks that are 20 square foot or larger.

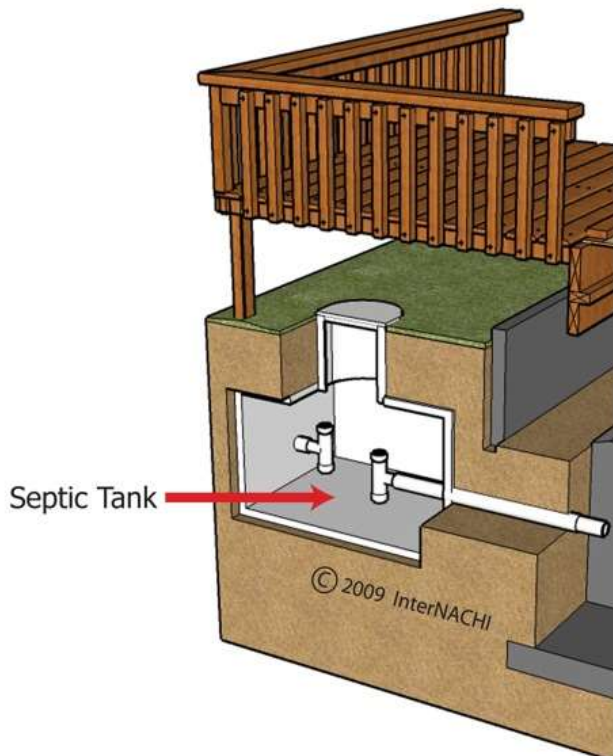
The image above depicts a deck located above a septic tank access. Decks should not be located where they might obstruct septic tank accesses, underground fuel storage tanks, well heads, or buried power lines.

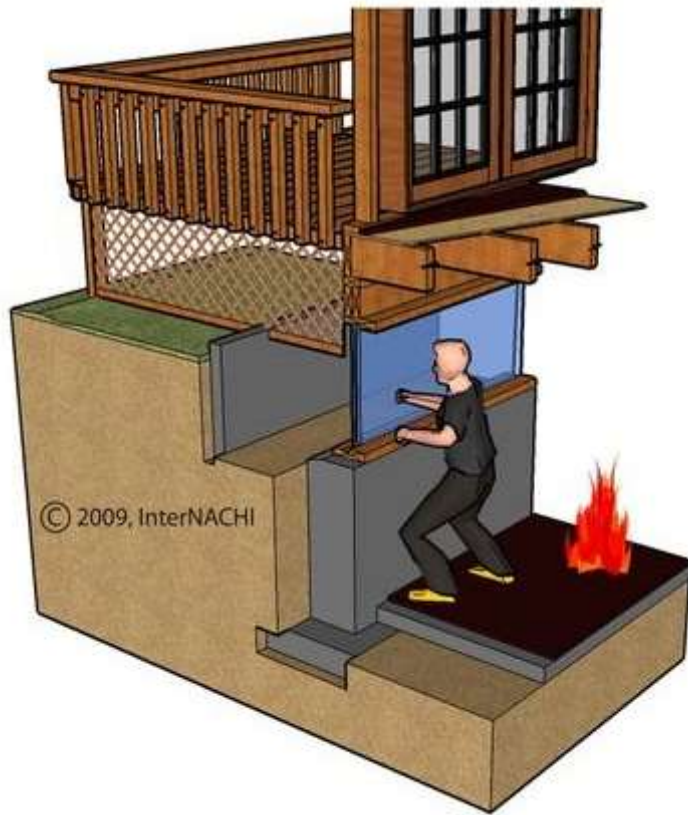
The image above depicts a deck obstructing a basement bedroom's emergency egress window. Egress openings under decks and porches are acceptable, provided the escape path is at least 36 inches (914 mm) in height, and the path of egress is not obstructed by infill or lattice.
